The MOD are considering the development of a Deep Space Advanced Radar Capability (DARC) facility at Cawdor Barracks. This study was required to determine the environmental quality of the ground conditions of the Site and to assess the potential for related human health and environmental risks associated with the current use (anticipated to generally reflect the proposed future use).

The purpose of this Phase 1 LQA has been to determine the environmental quality of the ground conditions at the Site and to assess the potential for human health and environmental risks. It is understood that the Site has been identified for the potential development of a radar facility as part of Project DARC. Continuation of the current commercial land use scenario has been considered in this Phase 1 LQA.

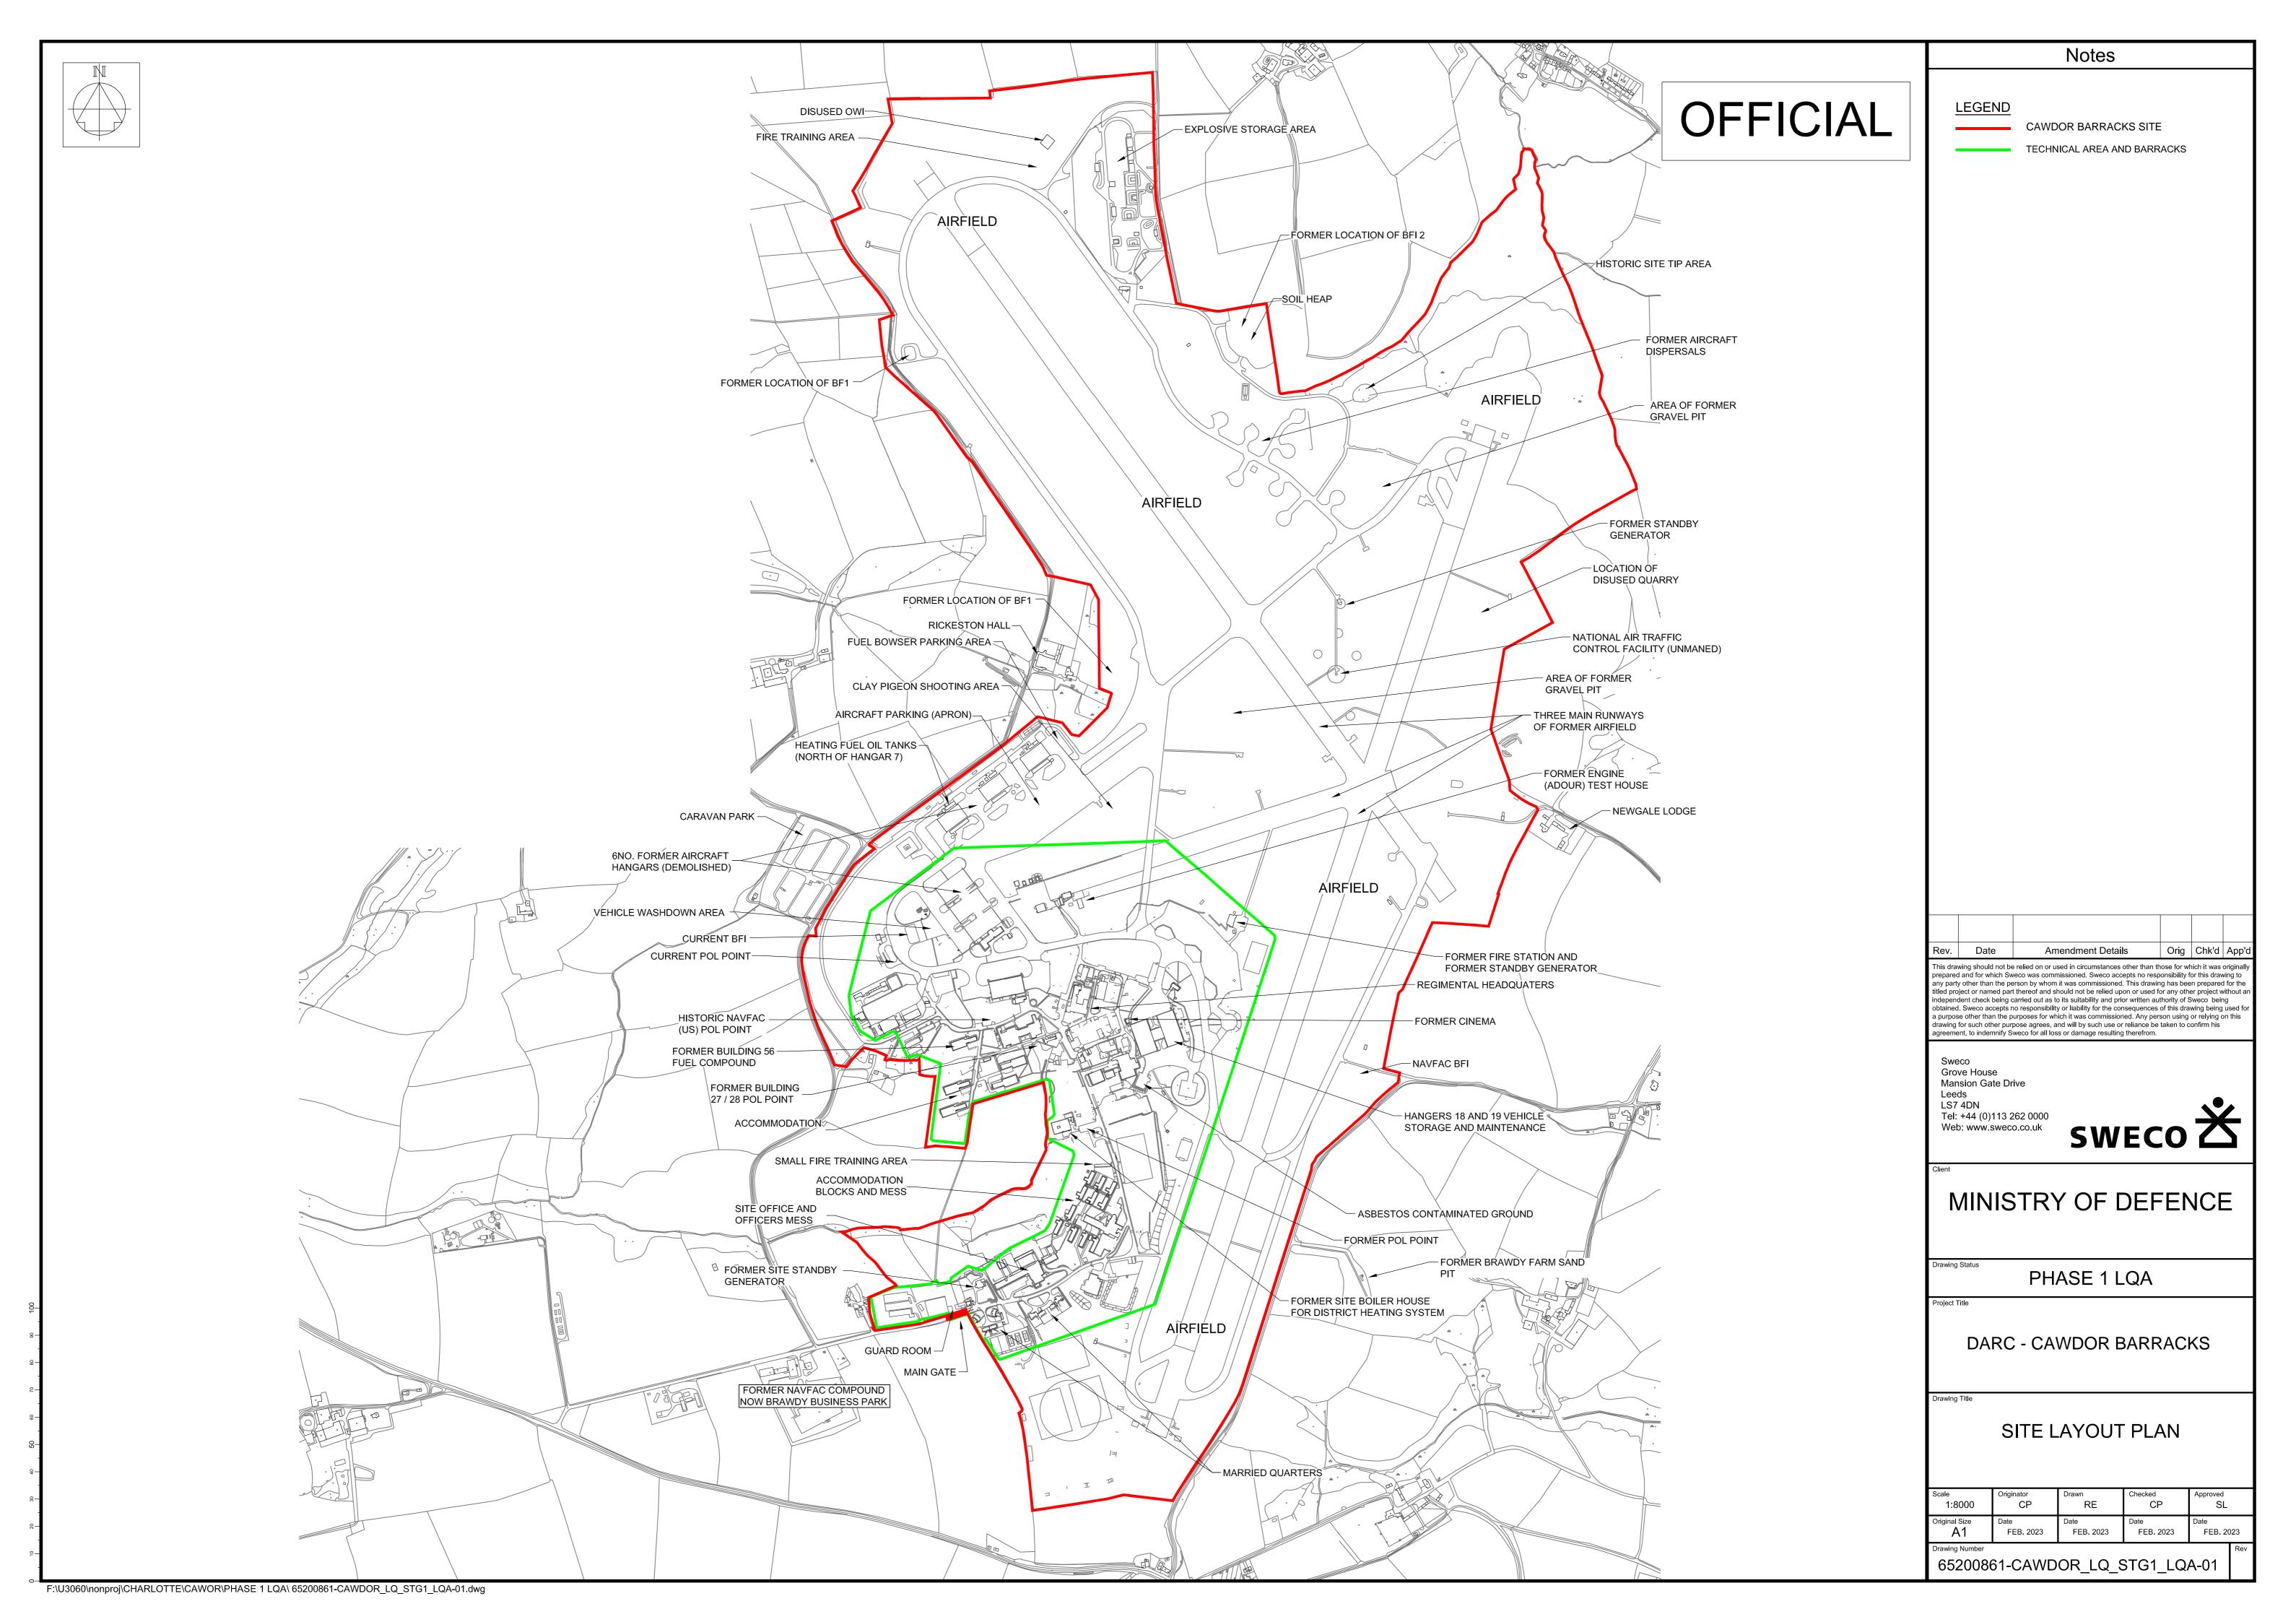
Drawing 65200861-CAWDOR_LQ_Stg1_LQA_01

Site Layout Plan

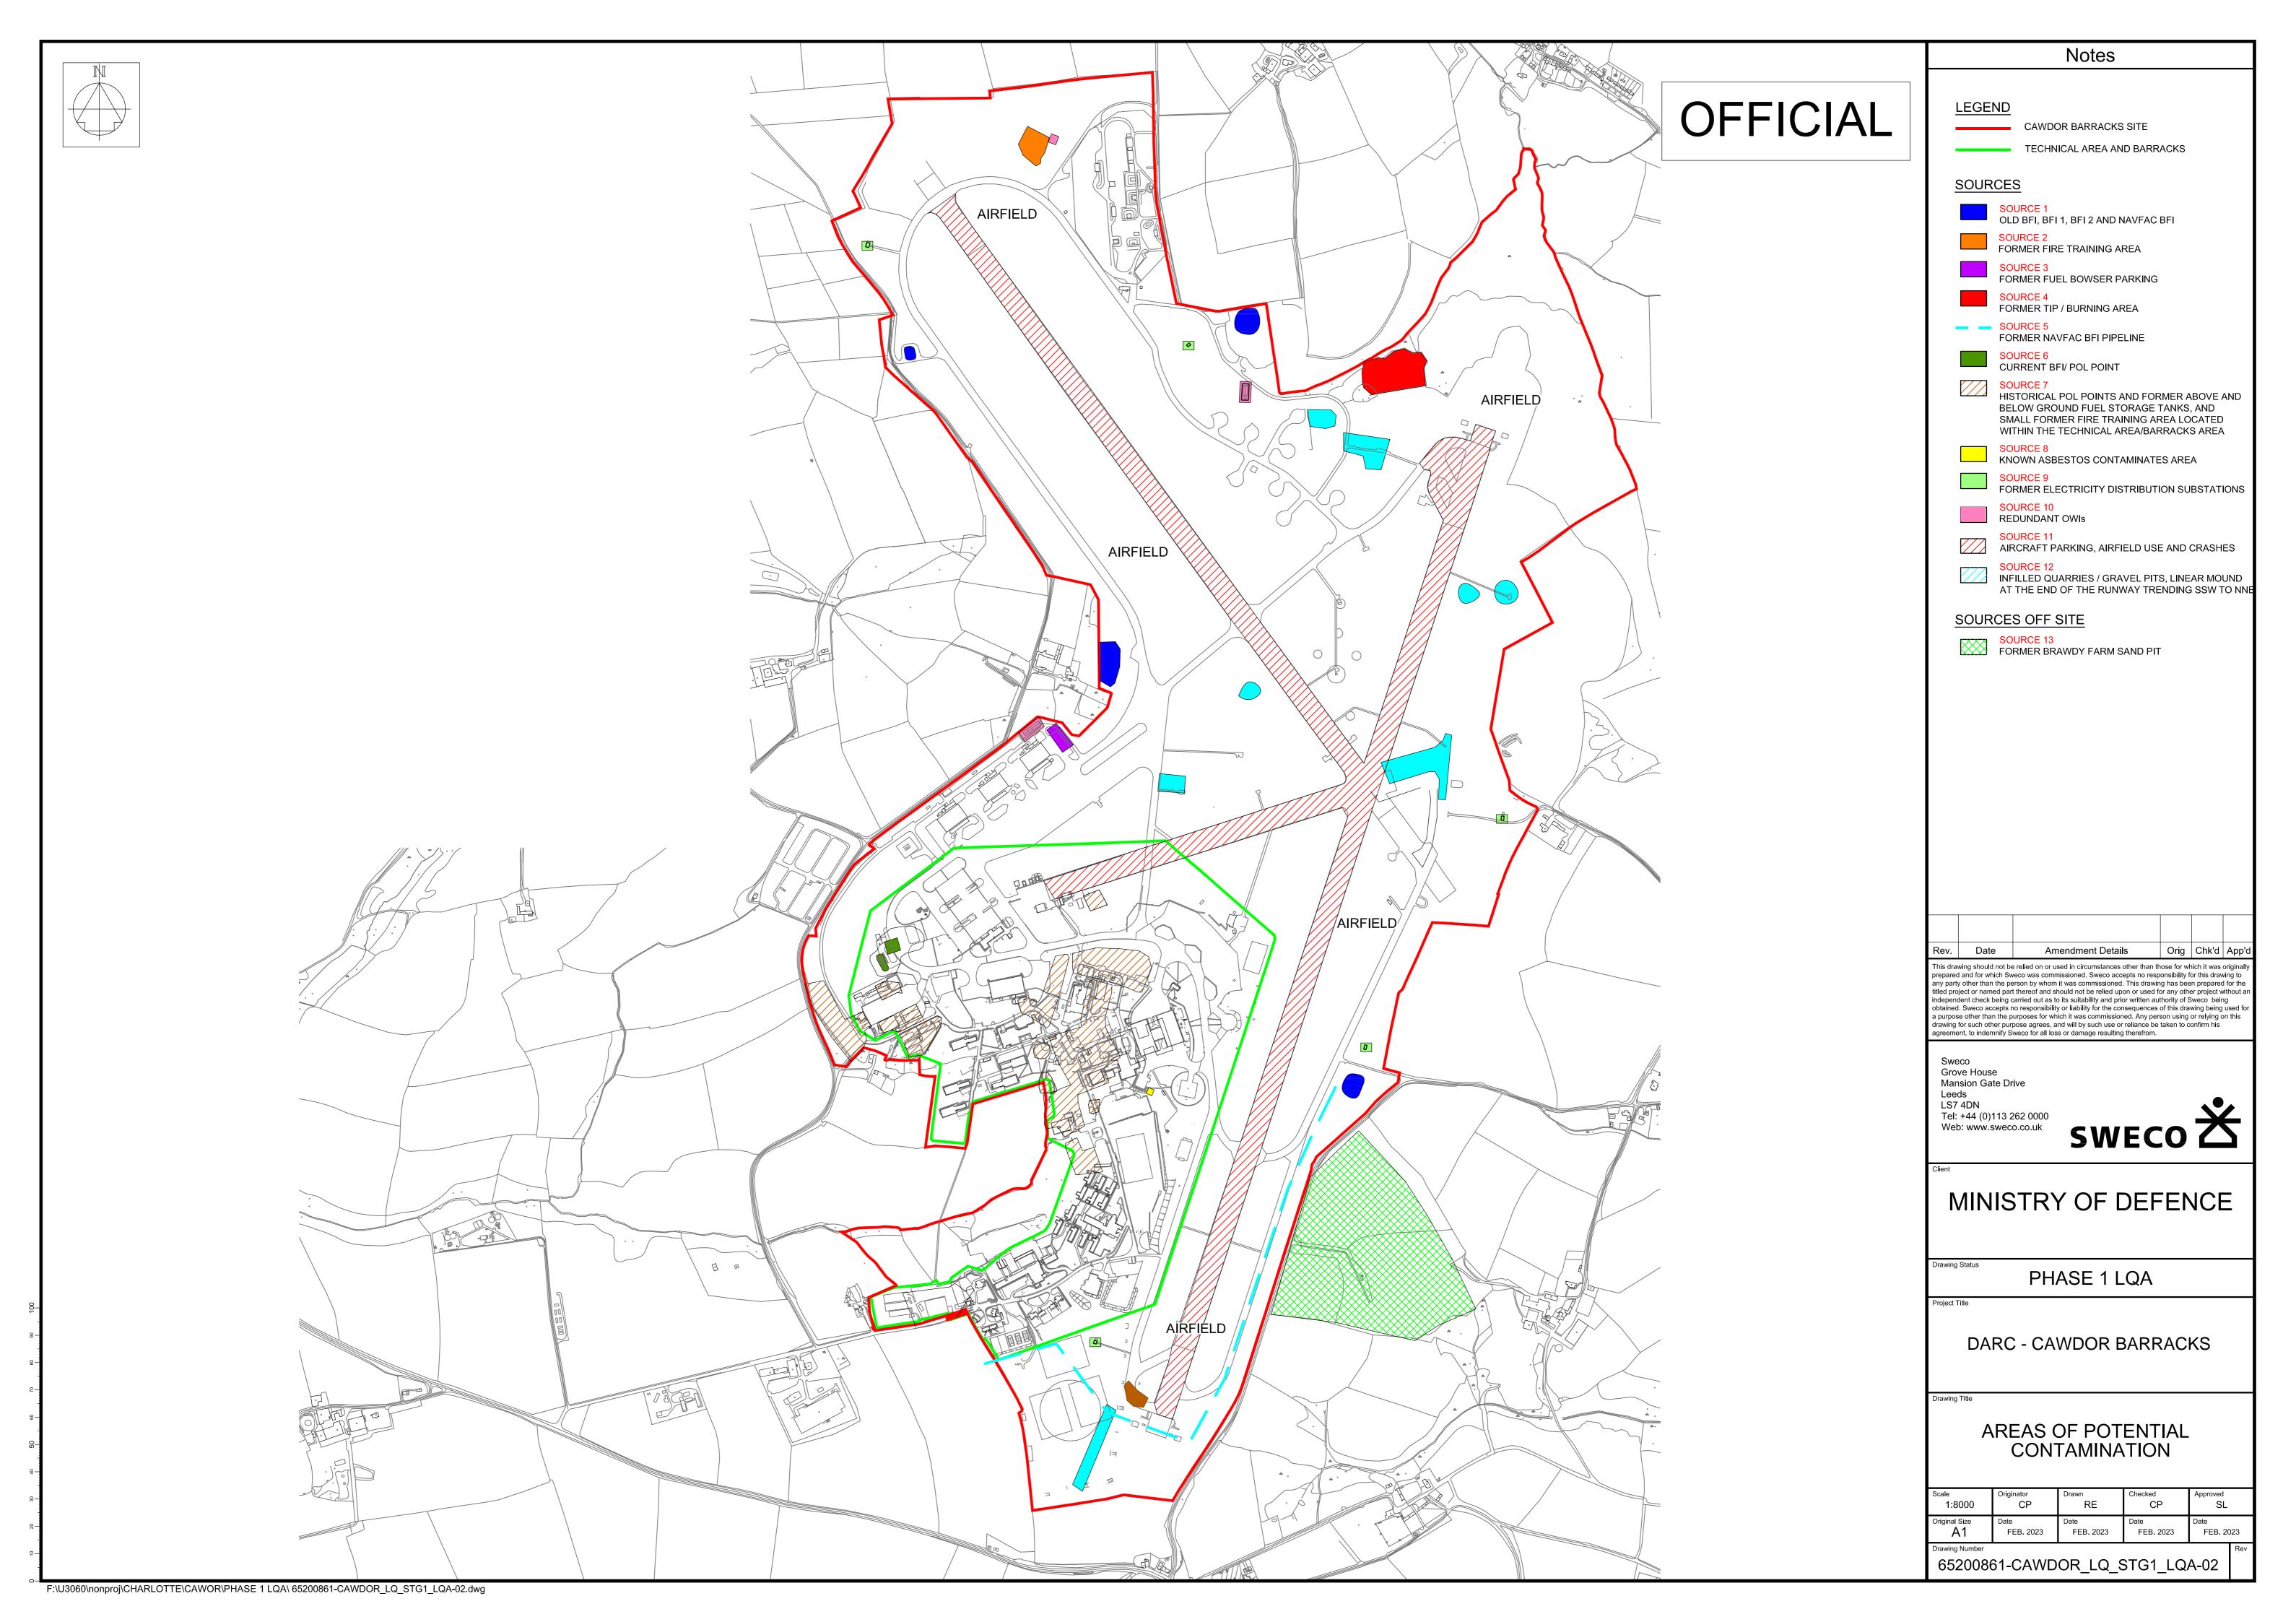
Drawing 65200861-CAWDOR_LQ_Stg1_LQA_02

Areas of Potential Contamination

- Source 1: Former Bulk Fuel Installations (Old BFI, BFI 1, BFI 2, and NAVFAC BFI);
- Source 2: Former Fire Training Area (FTA);
- Source 3: Former Fuel Bowser Parking:
- Source 4: Former tip/burning area;
- Source 5: NAVFAC BFI Pipeline;
- Source 6: Current BFI/POL Point;
- Source 7: Historical POL points and former above and below ground fuel storage tanks, and small former fire training area located within the technical area/barracks area;
- Source 8: Known asbestos contaminated area;
- Source 9: Infilled guarries/gravel pits, and linear mound, and;
- Source 10: Offsite former Brawdy Farm sand pit.

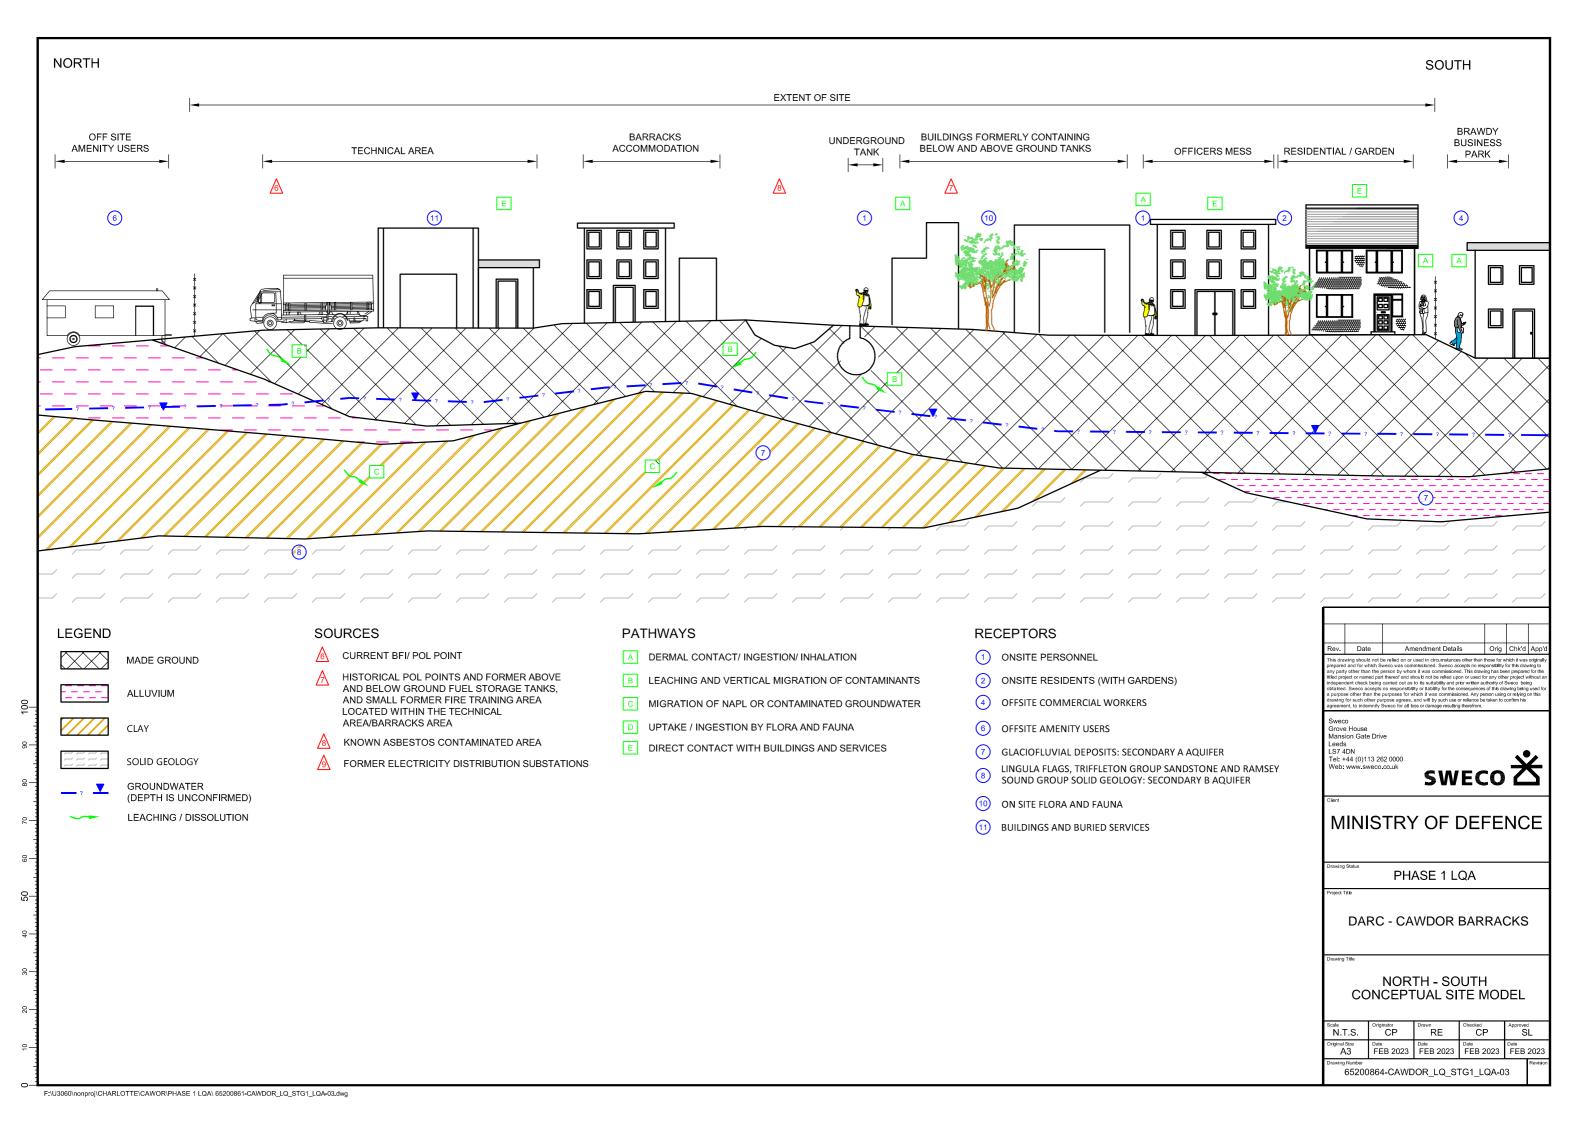
Drawing 65200861-CAWDOR_LQ_Stg1_LQA_03

Conceptual Site Model (North-South)

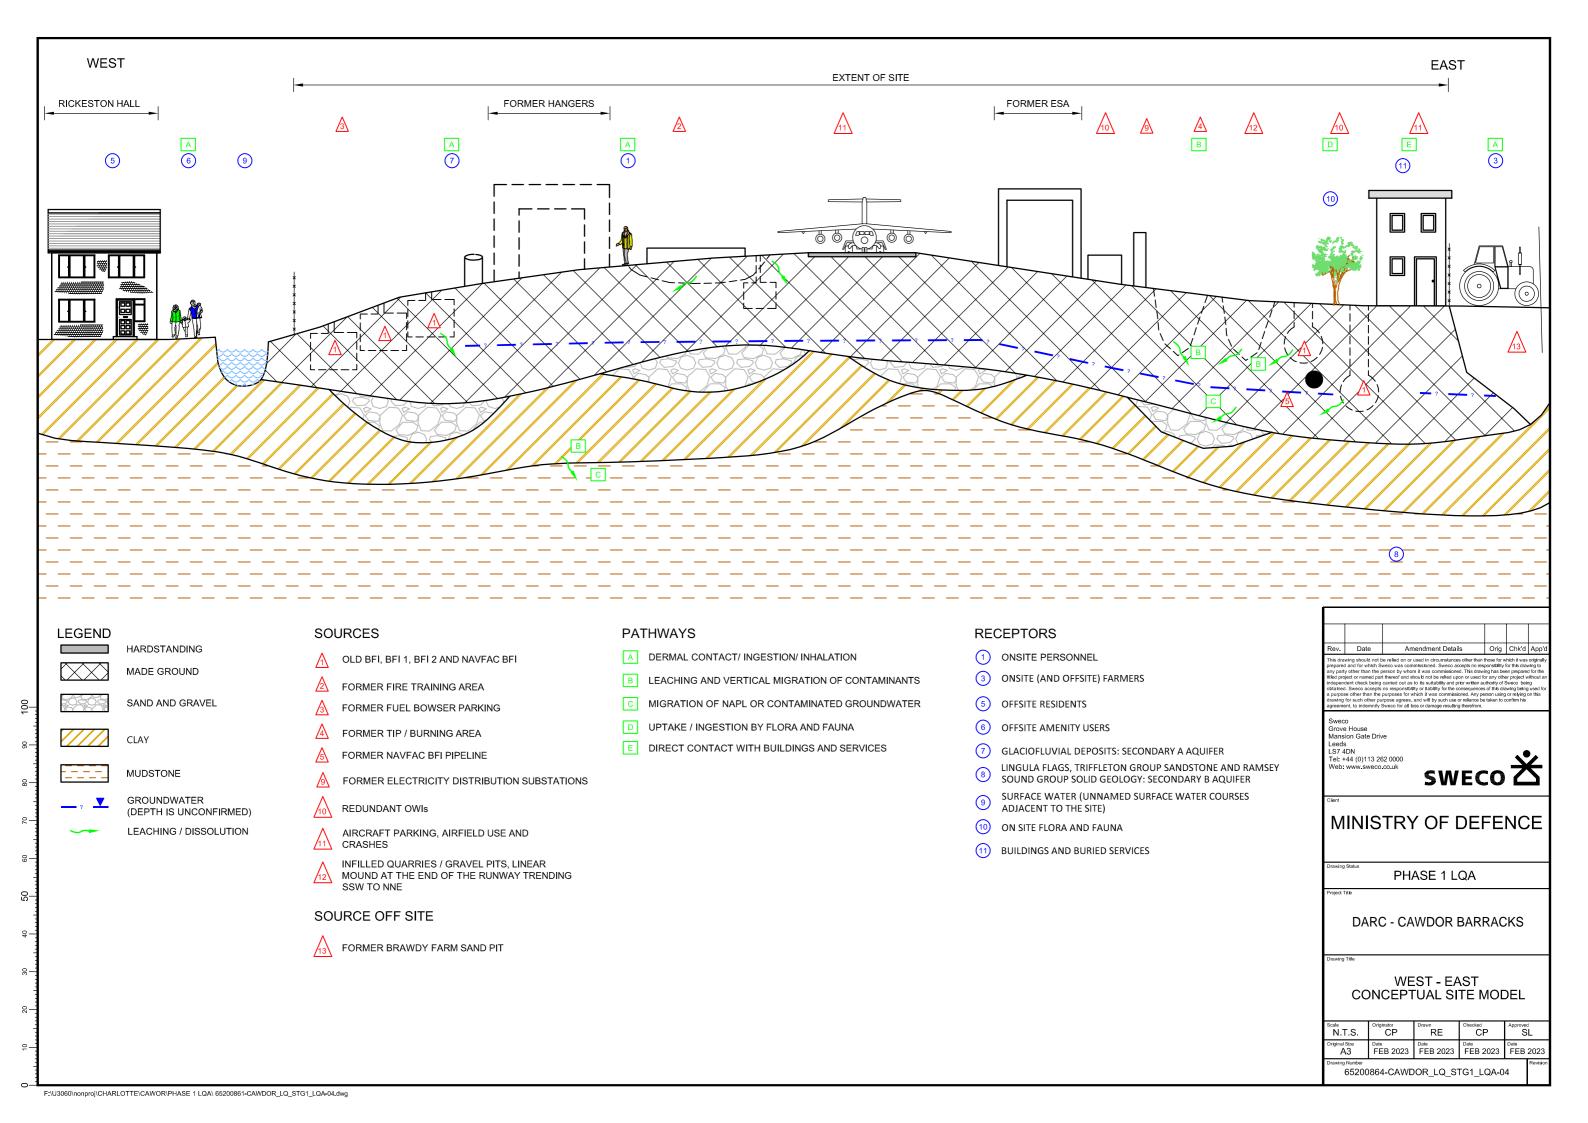
Drawing 65201348-CAWDOR_LQ_Stg1_LQA_04

Conceptual Site Model (West- East)
